**TÜV SÜD Auto Plus GmbH**  
Gutenbergstr. 13  
70771 Leinfelden-Echterdingen

Inspection date: 7 Apr 2025  
**Protocol number:** 39204349  
Delivery date: 7 Apr 2025

**WBA6N71040FK99912**

| <b>Manufacturer</b> | BMW | <b>Next maintenance in</b> | 22,000 km |

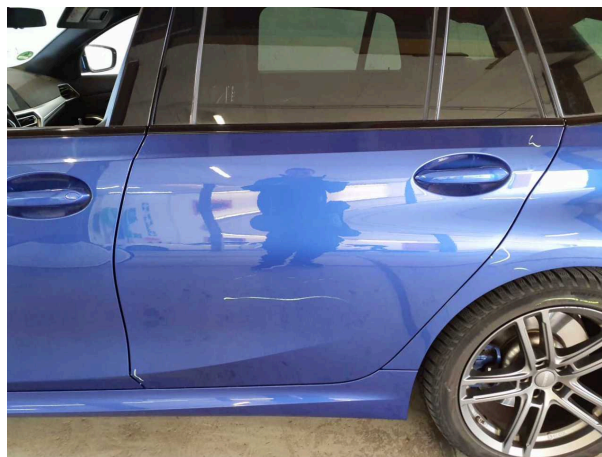
**Damage #21:** Door - rear left side: Door - Scratched - Paint
