WBA11AG050CF79255

Operator		Inspection condition	conditional: light/ moisture/dirt
License number		Mileage (Read)	24,105 km
Manufacturer	BMW	Next maintenance in	-3 Monat(e)
Type / Model	5er-Reihe 530e Limousine4-türig 1998 ccm 292 PS / 215 KW Elektrisch 8-Gang Automatik	Main inspection (Report not on hand)	
Vehicle Identification number	WBA11AG050CF79255	Power / Engine displacement	215 kW / 1,998 ccm
First registration	12 Nov 2020	Upholstery/Colour	/
Last maintenance		Paintwork	
Fuel type	Hybrid P / E ext. charg.	Gearbox	Automatic

Zustandsbericht

Inspection date: 9 Jan 2025
Protocol number: 37870309

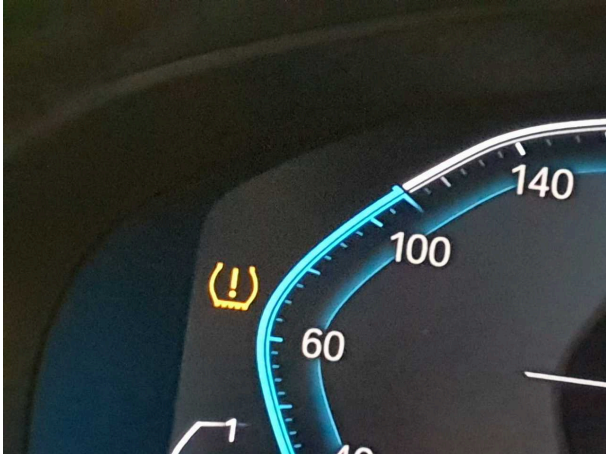
Damage #1: Wheel / tyres: Tyre - front left side - Leaking - Perform diagnosis

No.	Component group	Description
1	Wheel / tyres	Tyre - front left side - Leaking - Perform diagnosis
2	Documents	Main inspection certificate (Fehlt) - Replace
3	Misc.	Inspection / maintenance - Due - Replace

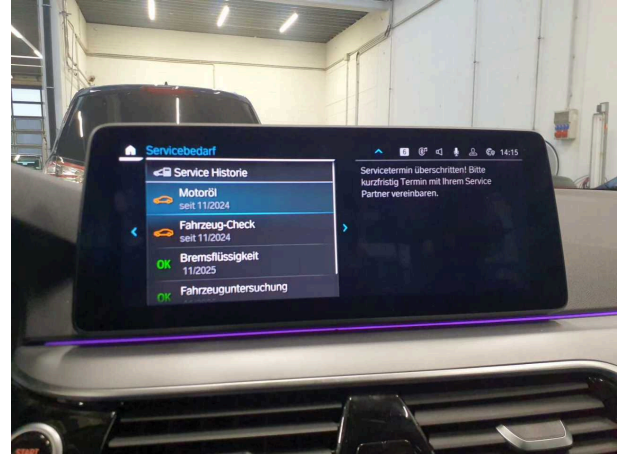
Damage #3: Misc.: Inspection / maintenance - Due - Replace
