WBA11AH080CG56344

Zustandsbericht

Inspection date: 10 Mar 2025
Protocol number: 38775813
Delivery date: 10 Mar 2025

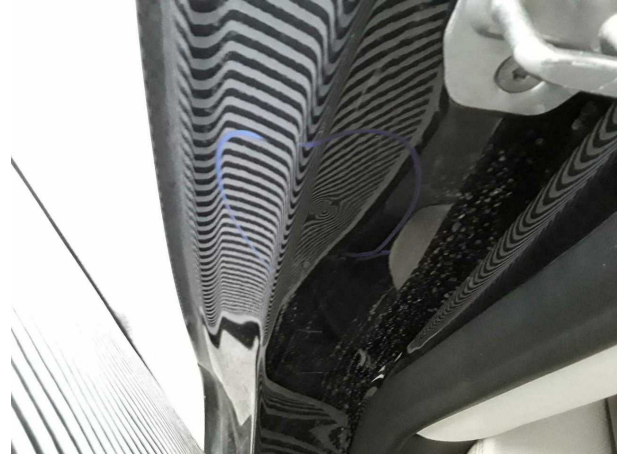
Damage #1: Side panel - rear right side: Sill - dent(s) - Smooth repair work

No.	Component group	Description
1	Side panel - rear right side	Sill - dent(s) - Smooth repair work
2	2nd wheel set	1 alloy rim - Scratched - Loss in value

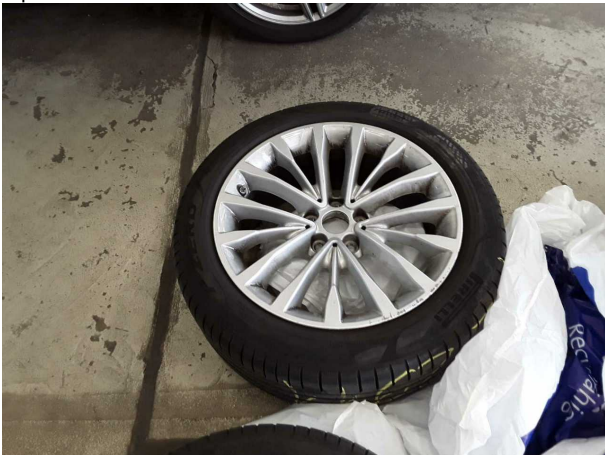
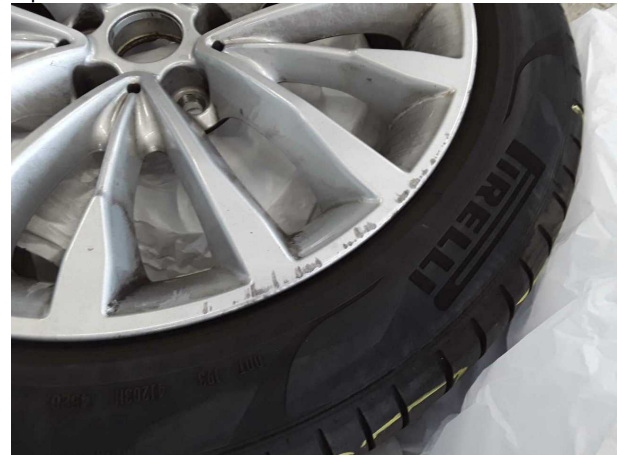
Damage #2: 2nd wheel set: 1 alloy rim - Scratched - Loss in value
