**WBA51BM040CN04197**

## Vehicle details

## Zustandsbericht

Inspection date: 10 Mar 2025  
**Protocol number: 38816181**

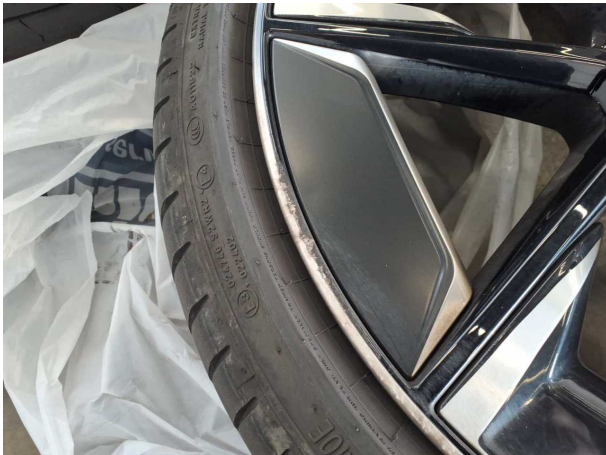
| No. | Component group | Description |
|---|---|---|
| 1 | 2nd wheel set | 1 alloy rim - Scratched - Loss in value |

**Damage #1:** 2nd wheel set: 1 alloy rim - Scratched - Loss in value

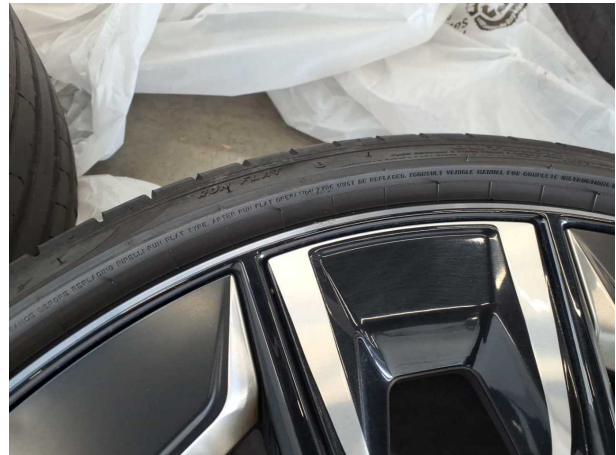
**Damage #1:** 2nd wheel set: 1 alloy rim - Scratched - Loss in value

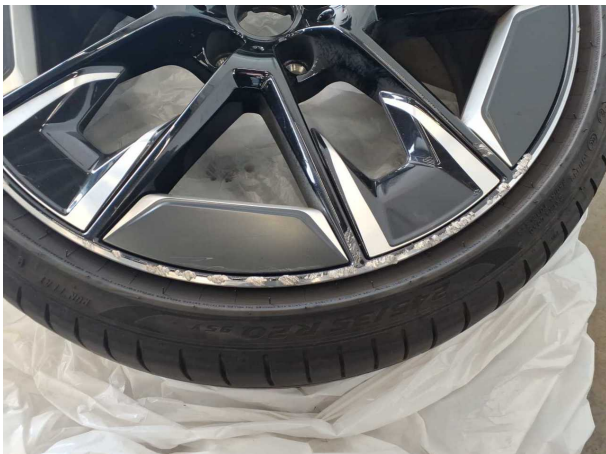
| No. | Component group | Description |
|---|---|---|
| 2 | 2nd wheel set | 1 alloy rim - Scratched - Loss in value |

**Damage #2:** 2nd wheel set: 1 alloy rim - Scratched - Loss in value

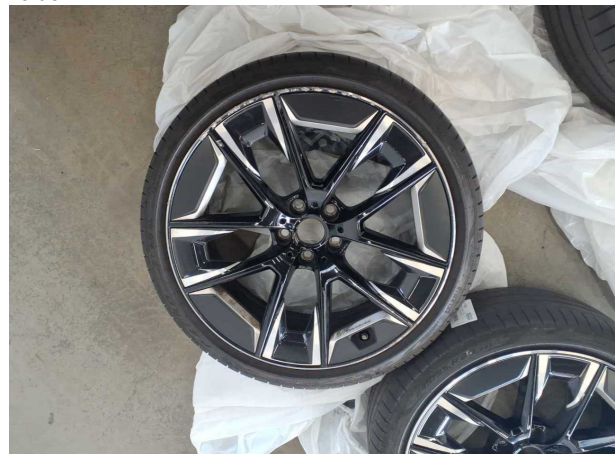
**Damage #2:** 2nd wheel set: 1 alloy rim - Scratched - Loss in value
