**WAUZZZGB5PR027934**

## Zustandsbericht

Inspection date: 9 May 2025  
**Protocol number: 39642160**  
Delivery date: 9 May 2025

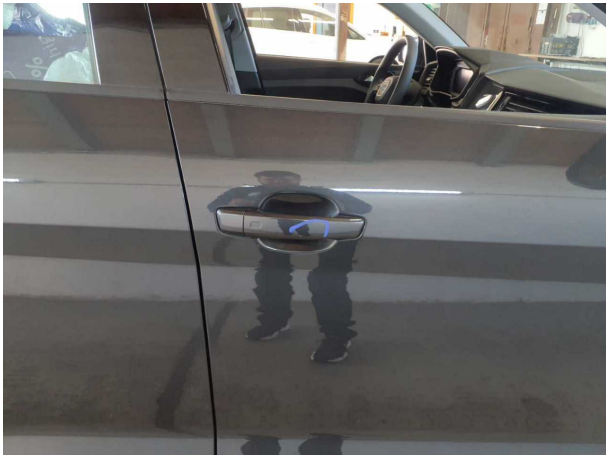
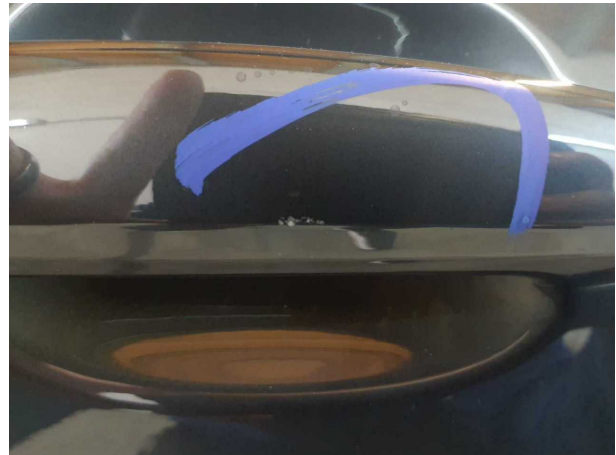
| No. | Component group | Description |
|---|---|---|
| 1 | Door - front right side | Door handle - outside - Scratched - Smart repair |

**Damage #1:** Door - front right side: Door handle - outside - Scratched - Smart repair

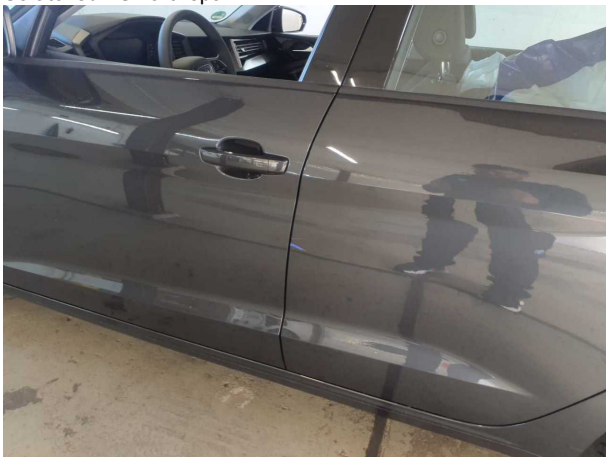
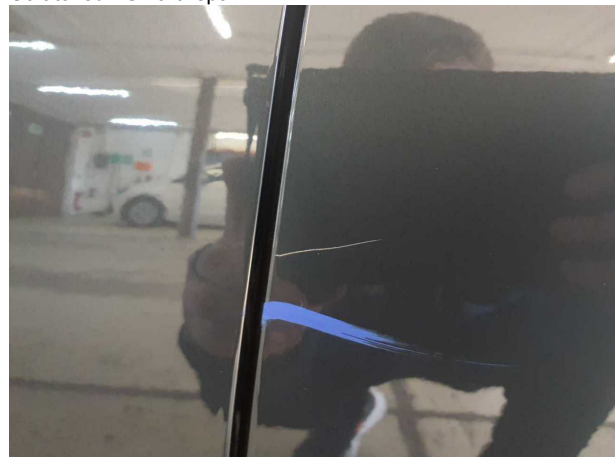
| No. | Component group | Description |
|---|---|---|
| 2 | Door - rear left side | Door - Scratch(es) - Paint |

**Damage #2:** Door - rear left side: Door - Scratch(es) - Paint
