**TÜV SÜD Auto Plus GmbH**  
Gutenbergstr. 13  
70771 Leinfelden-Echterdingen

Inspection date: 7 Apr 2025  
**Protocol number:** 39204349  
Delivery date: 7 Apr 2025

**WBA6N71040FK99912**

| <b>Manufacturer</b> | BMW | <b>Next maintenance in</b> | 22,000 km |

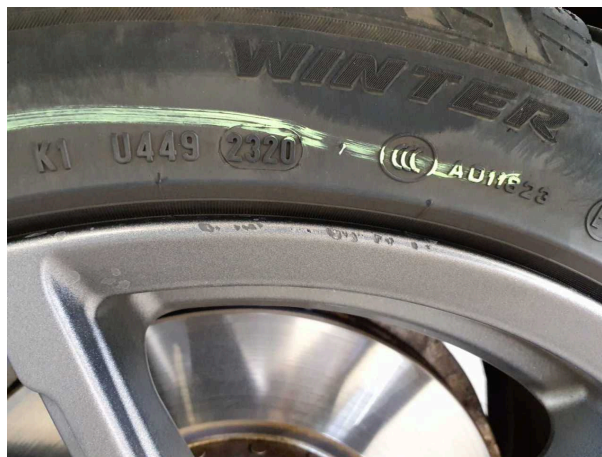
**Damage #1:** Wheel / tyres: Alloy rim - rear left side - Scratched  
- No deduction

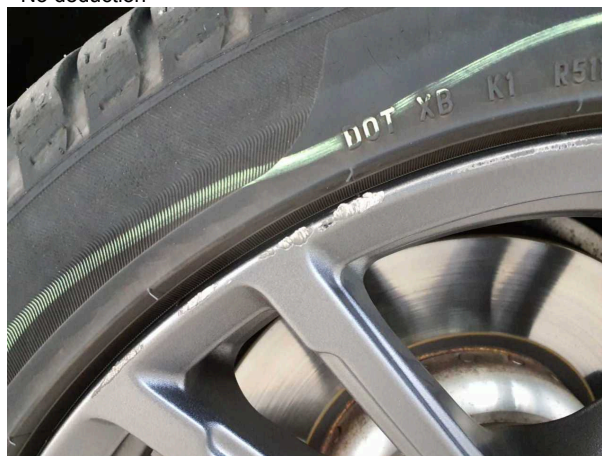
**Damage #2:** Wheel / tyres: Alloy rim - rear right side -  
Scratched - No deduction

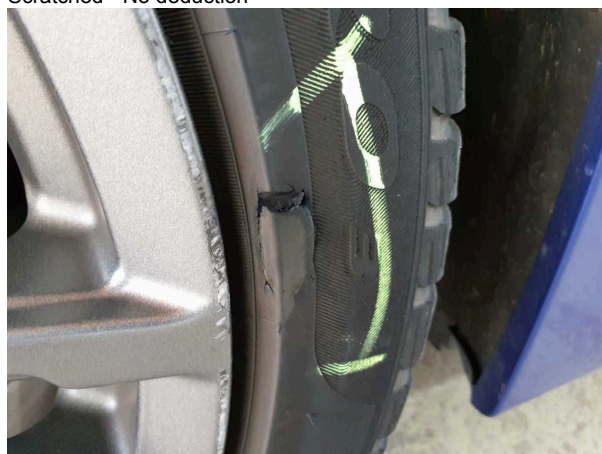
**Damage #3:** Wheel / tyres: Tyre - rear right side - Damaged -  
No deduction
